Docket No. 217 – Development and Management Plan Inspection

Northeast Utilities Service Company Certificate of Environmental Compatibility and Public Need for the construction of a 345-kV electric transmission line and reconstruction of an existing 115-kV electric transmission line between Connecticut Light and Power Company's Plumtree Substation in Bethel, through the towns of Redding, Weston, and Wilton, and to the Norwalk Substation in Norwalk, Connecticut.

Date: April 19, 2006

Location: Transition Stations: Hoyts Hill, Archers Lane, Norwalk Junction

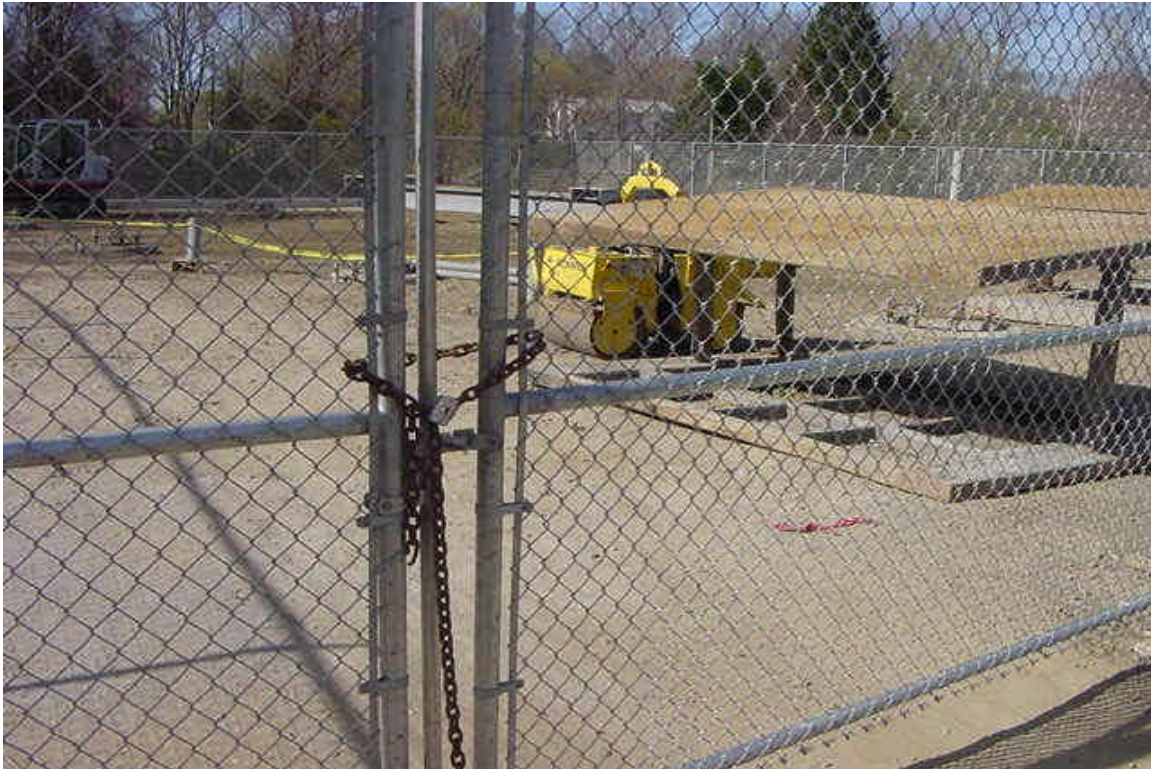
Hoyts Hill Transition Station: Photo shows the transition station pad where the active 345XLPE work was complete for now. 4/19/06

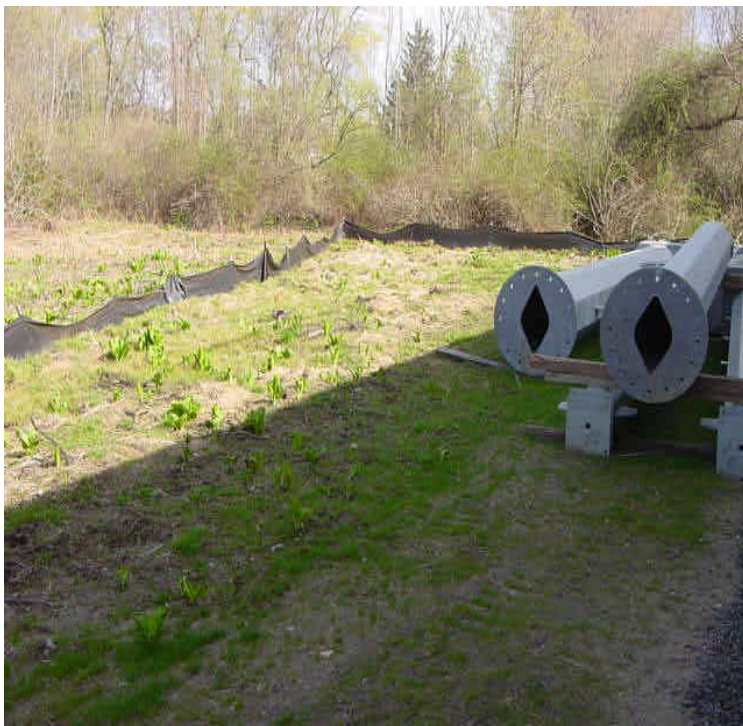
Photo on the left shows a view of the perimeter erosion controls which remain in fairly good shape. Photo on the right shows a view of the restored northern slope which was had some observable new grass growth. 4/19/06.

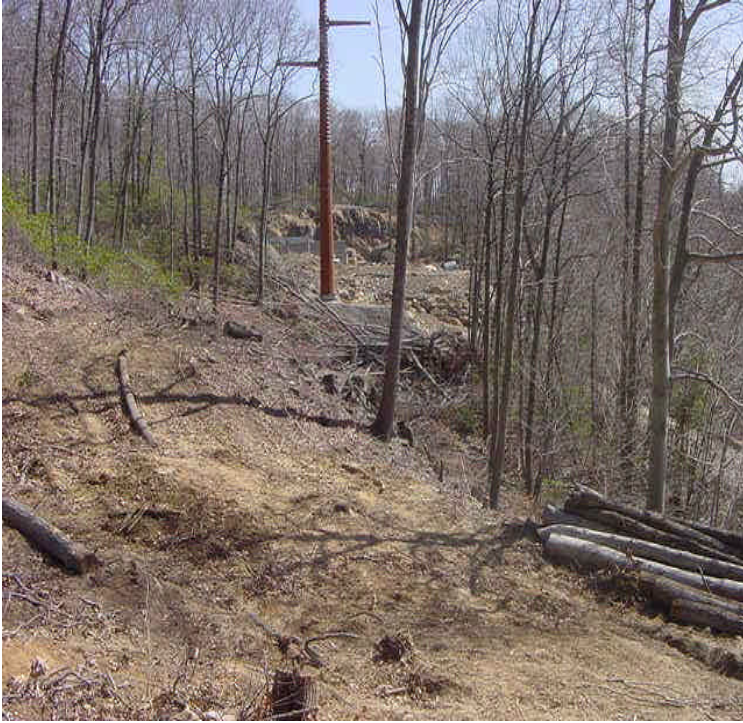
Archers Lane: Photo on the left shows a view of the cleared area from the ROW into the station. Photo on the right shows restoration efforts along the access drive. 4/19/06.

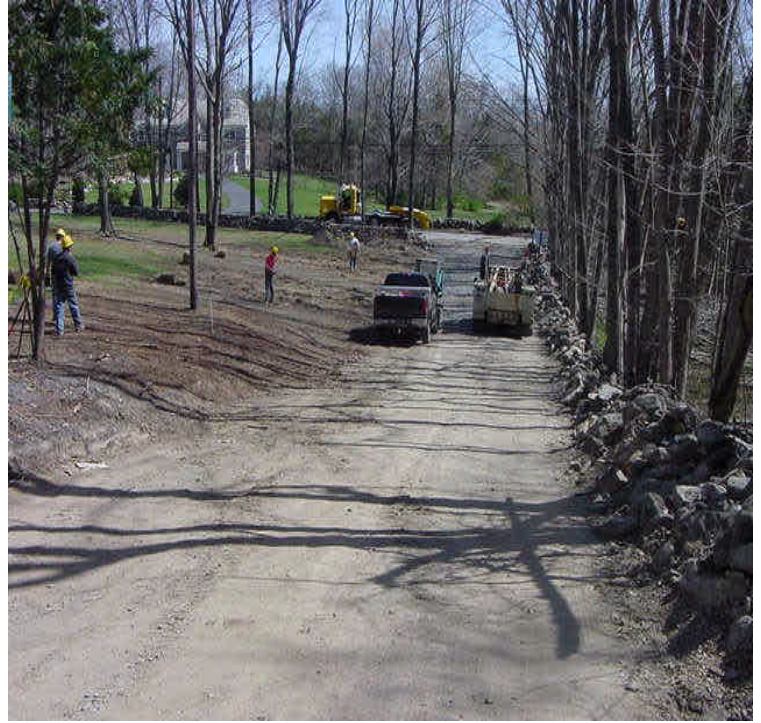
- Archers Lane: Water levels at the wetland crossings on the access road to the ROW remain below problem levels. 4/19/06.	-Crossings and controls are in good shape with the exception of attention needed near the first wetland. 4/19/06.	-N/A
	-Restoration efforts were noted along the access drive at the adjacent homeowners. 4/19/06	-None at this time. 4/19/06	-N/A

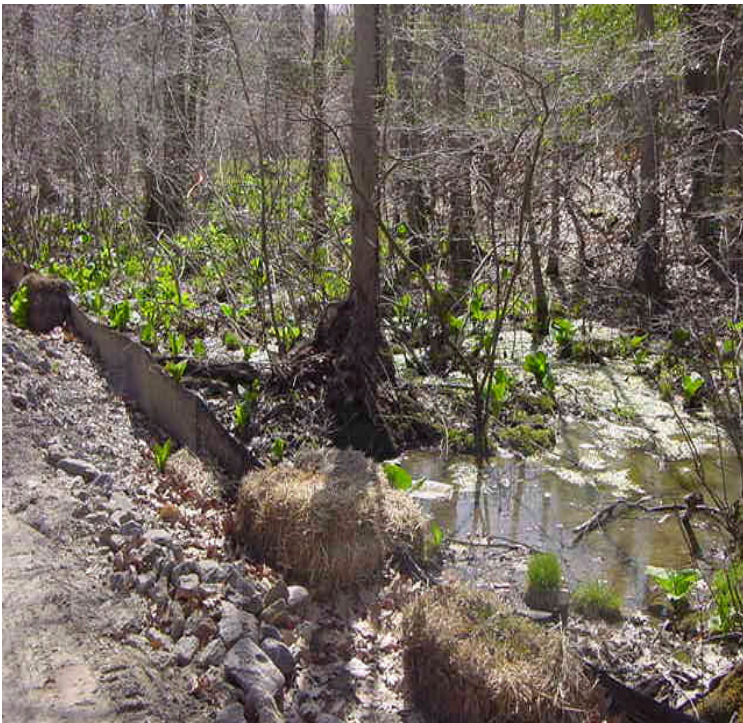
<p>- Archers Lane: Sediment was removed beyond the fence and at the 2nd wetland but efforts are still needed at the 1st wetland. 4/19/06.</p> <p>-Restoration efforts to seed and mulch were noted along the access drive at the adjacent homeowners property.</p>	<p>Any easily accessible deposits of sediment need to continue to be removed. Fine layers of silt can remain. 4/6-4/19/06</p> <p>-None at this time. 4/19/06</p>	<p>-Restoration efforts were noted.</p>

Photo on the left shows the 1st wetland crossing near the station. Sediment accumulation remains here and needs to be removed. Photo on the right shows excavation and erosion controls at an adjacent property. The work is unrelated to this project. 4/19/06.

Areas of Inspection	Observation	Recommended Action	Corrected Actions
encroachment and mitigation	<p>-Archers Lane: Watch run-off velocity down the completed slopes and walls. Efforts need to continue removing deposited sediment from the 1st wetland crossing. 4/19/06.</p> <p>- Norwalk Junction: The outlet of the drainage swale is at the headwall of the wetland area. Sediment has been an issue here in the wetlands but has not had a significant impact on the river. 12/30-4/19/06.</p>	<p>4/19/06.</p> <p>- Continue to remove the sediment from the wetland where there are significant buildups. 2/16-4/19/06.</p> <p>-See Erosion Control Section for more details. Reduce turbidity by controlling its source-disturbed surfaces on site. 12/30-4/19/06.</p>	-N/A
State species of concern, threatened and endangered species	- No species of concern are located in these areas of construction.	- N/A	-N/A
Vegetative clearing limits (including trees to save or danger trees noted)	<p>-Hoyts Hill: The southern slope still needs to be revegetated in the spring as necessary. Grass growth was occurring along the restored northern slope. 4/19/06.</p> <p>- Archers Lane: no additional clearing was noted here. 4/19/06.</p> <p>- Norwalk Junction: -No additional clearing is needed for the transition station work. 4/19/06. -Additional clearing associated with corridors in from the adjacent new ROW was complete. 4/19/06.</p>	<p>- Repairs to washouts on the south side will be needed. Determine whether additional seed will be necessary. 4/12-4/19/06.</p> <p>-None at this time. 2/23/06-4/19/06.</p> <p>- Restore areas along the perimeter of the station pad as feasible. 4/19/06.</p> <p>See Overhead Report for more details. 4/19/06</p>	<p>-The northern slope is stabilized with grass growing</p> <p>-N/A.</p> <p>- N/A until work is completed.</p> <p>-N/A</p>

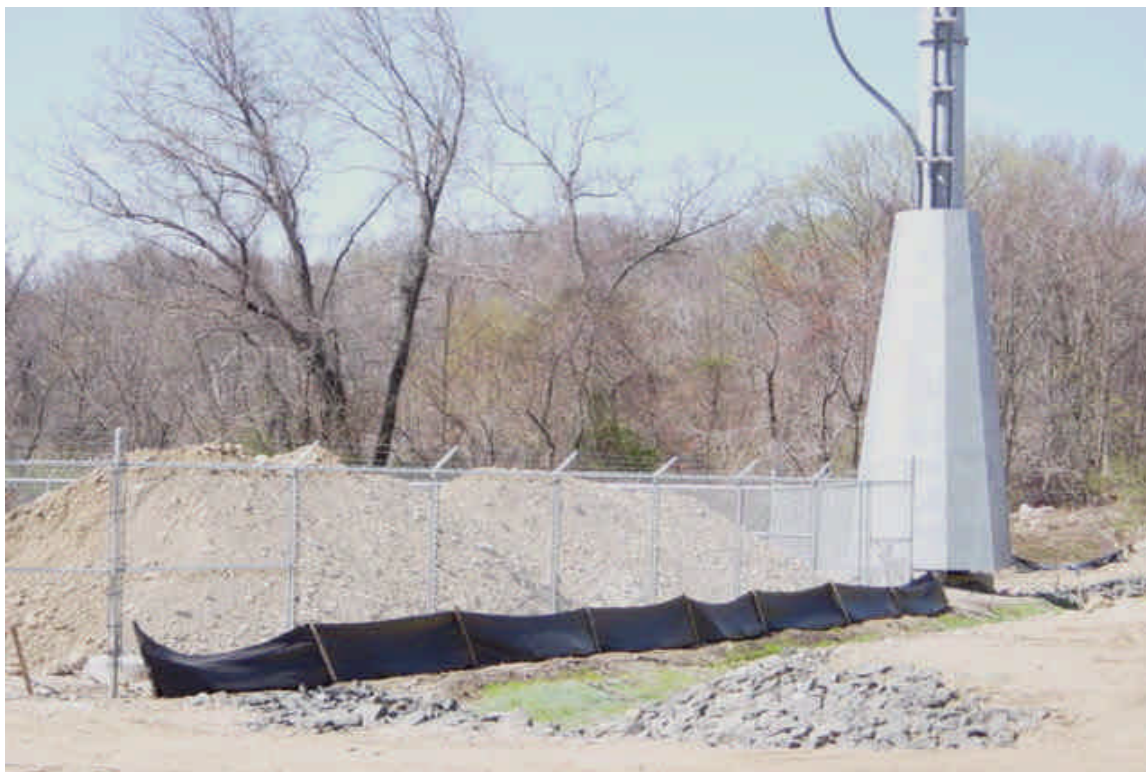
Norwalk Junction: Photo shows the stockpile along the perimeter fence and silt fence installed as recommended. 4/19/06.

- Sediment from small washouts along the slope of the swale introduces more potential for turbidity. 2/16-4/19/06.	- Sediment could be removed from the swale and the slumping or washouts should be repaired with further seeding or stabilization. 3/8-4/19/06.	
	-Silt fence was installed at the base of the stockpiles noted near the swale as recommended. 4/19/06.	- None at this time. 4/19/06	-Silt fence was installed.
Inland Wetland and Watercourse	- Hoyts Hill: The wetland remains well protected at this time. 4/6-4/19/06.	-Continue to monitor this area until slopes have stabilized completely .	- N/A.

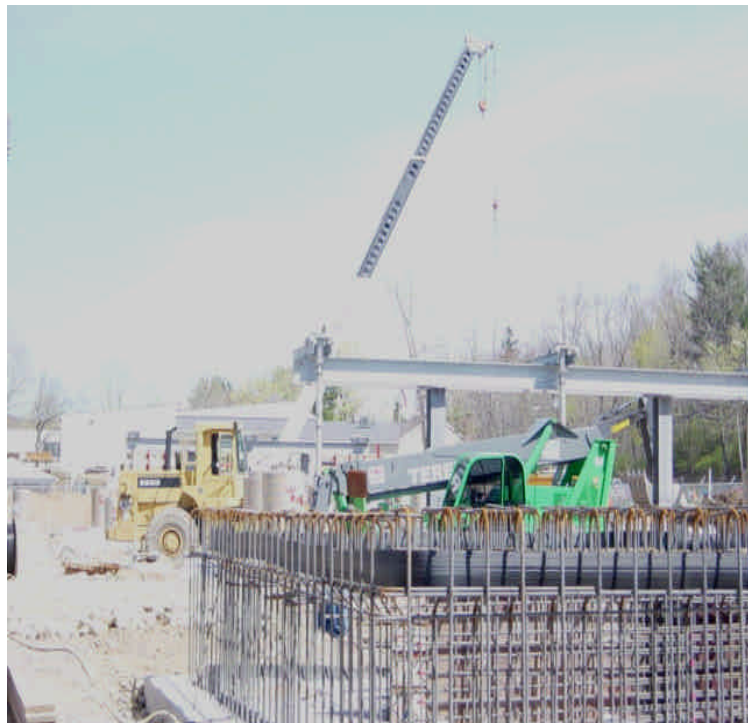
Photo on the left shows an overview of the foundation work and construction occurring within the yard. Photo on the right shows tower components being stored here with silt fence in good shape along the river. 4/19/06.
